The Darling Anabranch Adaptive Management Monitoring Plan Condition Monitoring 2010

Final Report for Public Distribution

March 2011

Final Report prepared for the Department of Environment, Climate Change and Water by The Murray-Darling Freshwater Research Centre.

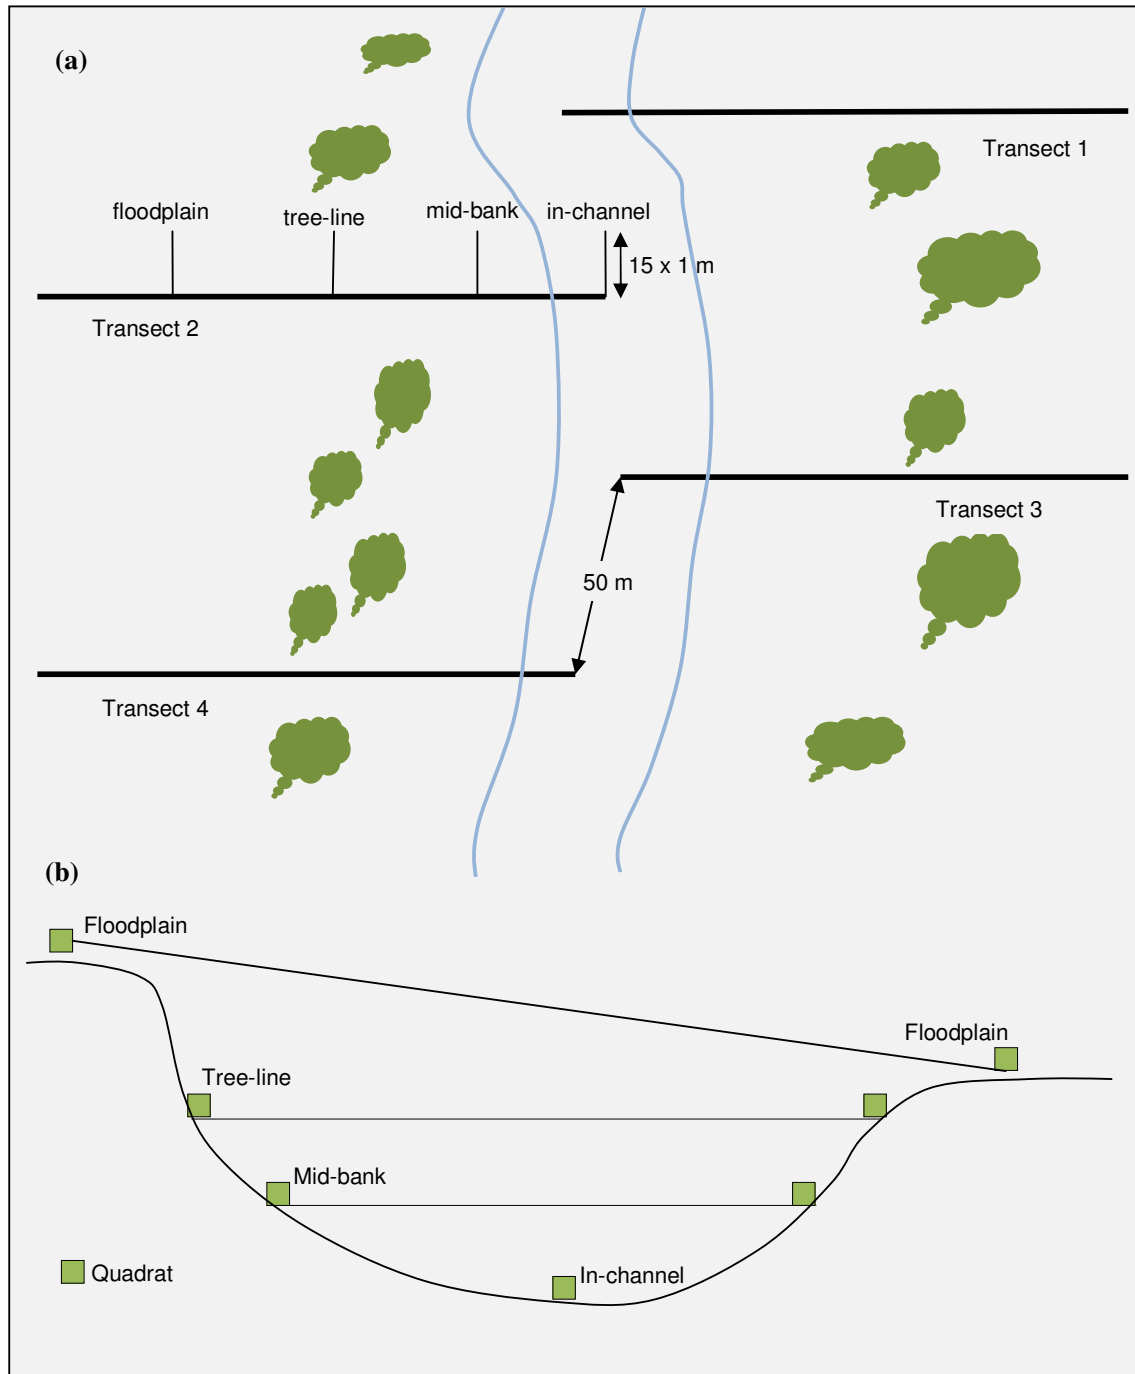
Figure 2.1. (a) Schematic diagram showing layout of understory vegetation transects and quadrats (b) Example of uneven channel morphology common at many of the Darling Anabranch sites.

Each quadrat consists of 15 cells of one metre by one metre (1 m × 1 m). A wooden stake was used to permanently mark the beginning and end of each quadrat and recorded with a hand-held GPS (GDA 94 datum). In each cell, the presence of any plant species was recorded if the plant was alive and its base within the cell. The frequency of occurrence of any plant within the 15 cells provided a semi-quantitative measure of abundance. The selection of 15 cells per quadrat was deemed sufficient based on species area curves (see Nicol and Weedon 2006).

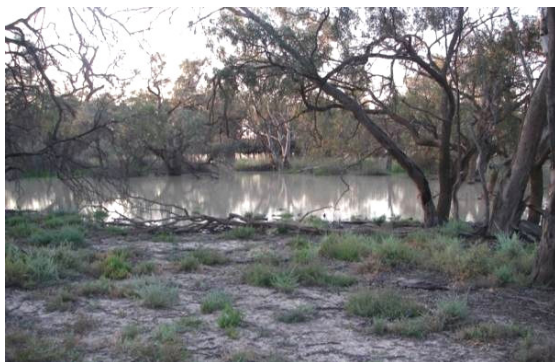
Figure 3.13. Photo point for site 5 (D. Bogenhuber, MDFRC, 21/9/2010).

Site 5 is located on Redbank Creek, just downstream of Packers Crossing on Tandou Station. The site is dominated by grey clay soils and the channel is wide and flat. The main channel and flood runners were inundated at the time of surveying (Figure 3.13). Black Box (BB) (*Eucalyptus largiflorens*) and River Red Gum (RRG) (*Eucalyptus camaldulensis*) are co-dominant along the edge of the channel, with BB extending onto the floodplain.

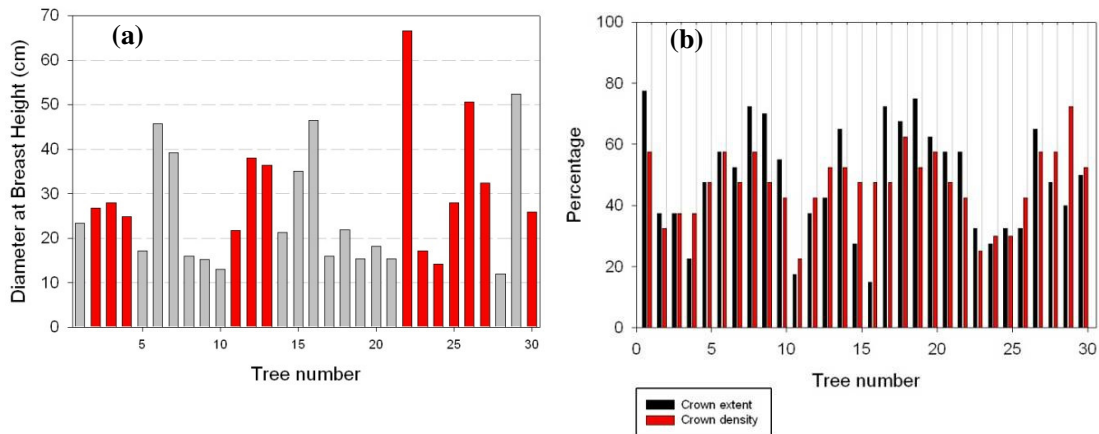
Figure 3.14. (a) DBH for all trees assessed at site 5. Grey is Black Box, red is River Red Gum. (b) Crown extent and crown density for all trees assessed at site 5.

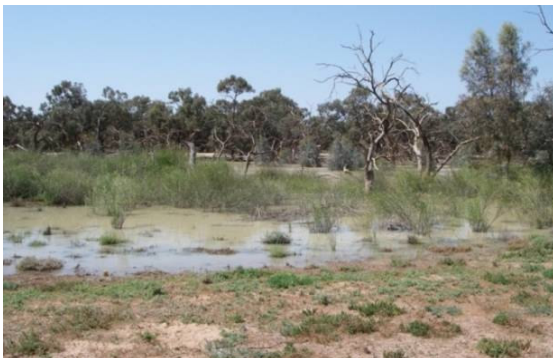
Figure 3.17. Photo point for site 6 (D. Bogenhuber, MDFRC, 22/9/2010).

Site 6 is located on Tandou Creek, at the Woolshed crossing on Tandou Station. The site is dominated by grey clay soils; the channel is wide and flat (Figure 3.17). The dominant tree species is Black Box (BB) (*Eucalyptus largiflorens*).

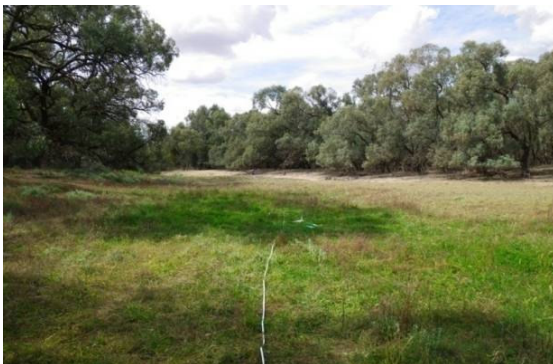
Figure 3.33. Photo point of site 9b (D. Bogenhuber, MDFRC, 12/10/2010).

Site 9b is located on the downstream side of Dam 183, Wyndham Station. The site is dominated by grey clay soils with fringing red sandy loam. The channel is wide and shallow (Figure 3.33) with steep banks on one side with large flood runners and waterholes. The dominant tree species is Black Box (BB) (*Eucalyptus largiflorens*).

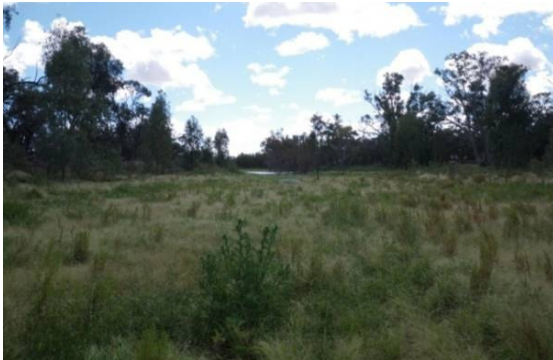
Figure 3.37. Photo point of site 10 (D. Bogenhuber, MDFRC, 12/10/2010).

Site 10 is approximately 1 km upstream of Bunnerungee Bridge on Bunnerungee Station. The site is dominated by red sandy loam. The channel is approximately 50 m wide and shallow (Figure 3.37) with thick regeneration of River Red Gum (RRG) (*Eucalyptus camaldulensis*) in the base. Black Box (BB) (*Eucalyptus largiflorens*) and RRG occur along the edge.

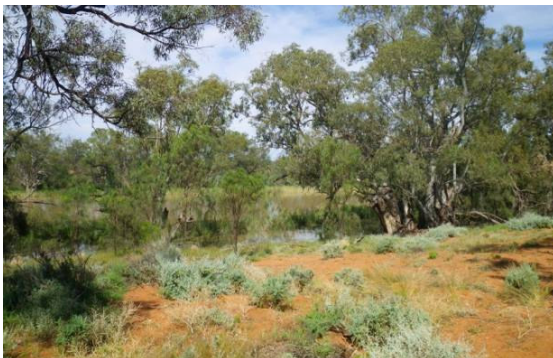
Figure 3.53. Photo point of site 15 (D. Linklater, MDFRC, 8/11/2010).

Site 15 is approximately 1 km upstream of Oakbank Dam on 'Oakbank Bend' Station (name adopted by authors) and under the influence of the Murray River Lock 9 weir pool (Figure 3.53). Condition Monitoring was restricted to the steep eastern bank due to access restrictions on the western side. The overstorey consists of Black Box (BB) (*Eucalyptus largiflorens*), River Red Gum (RRG) (*Eucalyptus camaldulensis*) and River Cooba (RC) (*Acacia stenophylla*).

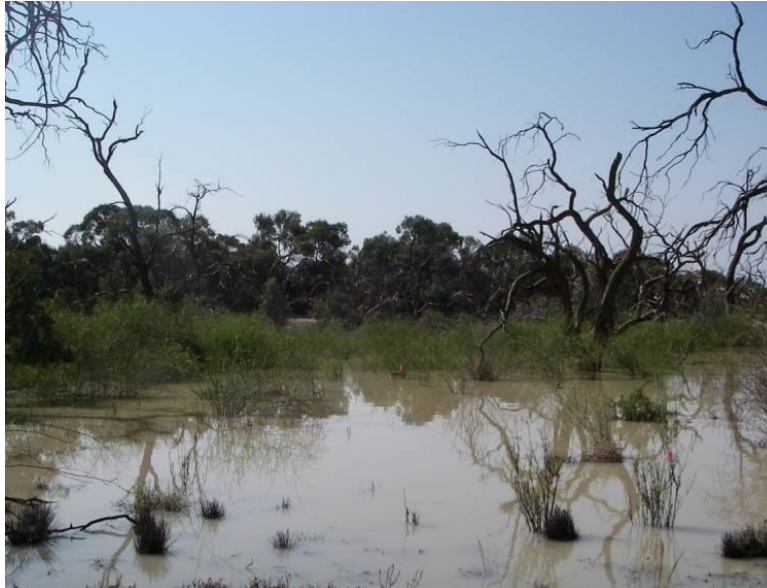
Figure 4.13. Lignum community at site 6, Tandou Creek (D. Bogenhuber, MDFRC, 22/9/10).

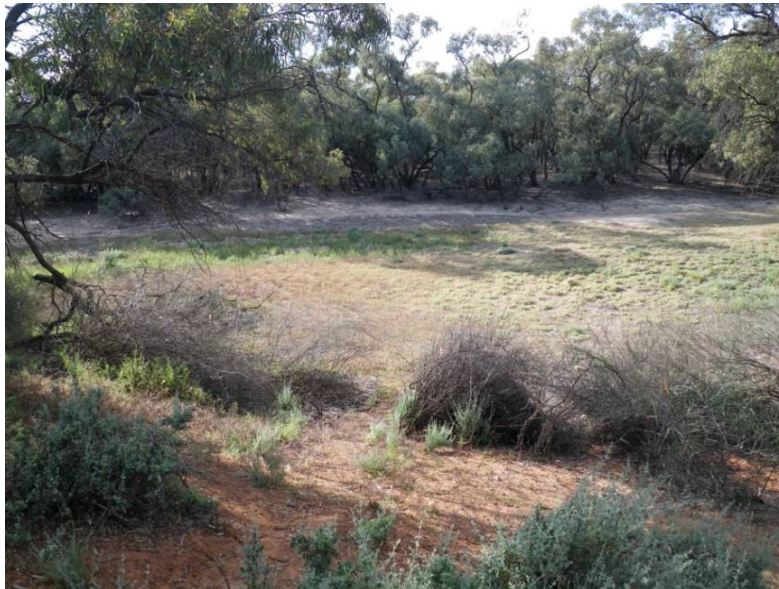
Figure 4.14. Photo of site 9b taken from high side of channel looking towards waterhole and across to a low bench with dense Black Box (D. Bogenhuber, MDFRC, 12/10/2010).

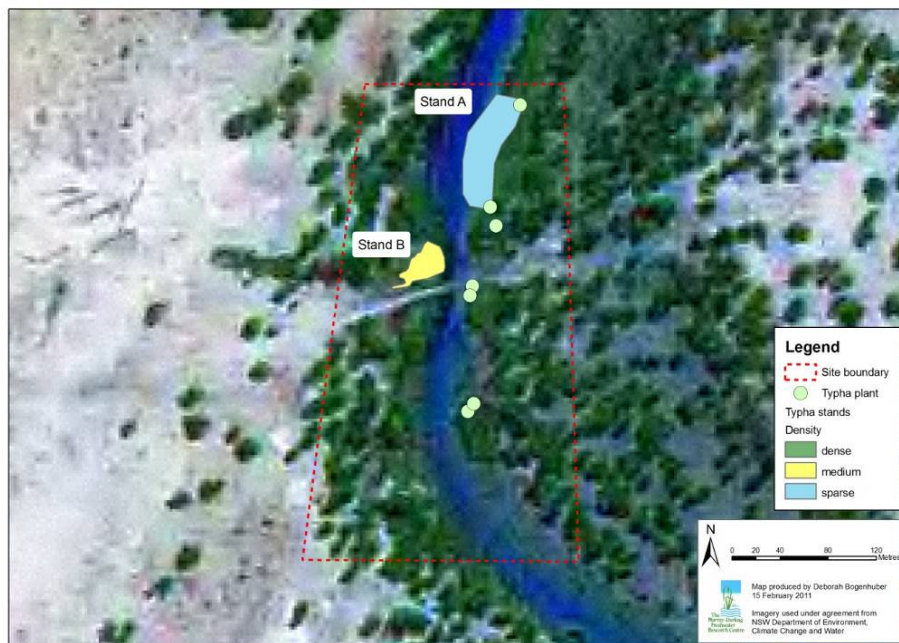
Figure 4.15. Distribution of *Typha* at site 6, Tandou Creek, Darling Anabran system.

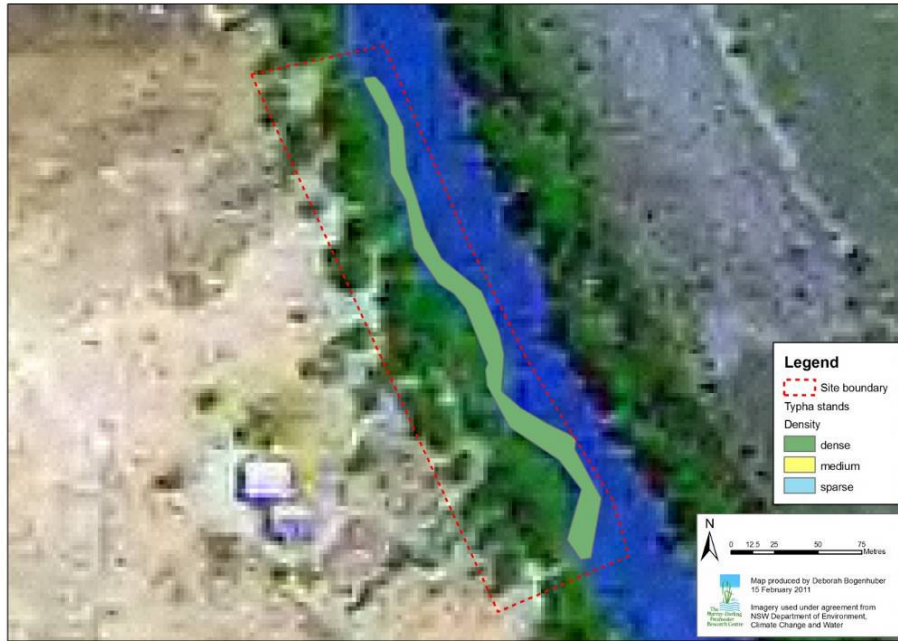
Figure 4.16. Distribution of *Typha* at site 15, Darling Anabranh.

The generally stable water level in the Lock 9 weir pool provides ideal conditions for the development, growth and expansion of *Typha* at sites 15 and 16. The dense stands around Oakbank Dam suggest that the operation of this structure may also have favoured its growth. These stands are expected to remain stable or expand even further under a permanent water regime. It is possible that the current high water levels in the Murray River may place stress on the existing *Typha* stands, however, the average height of plants (3 to 4 m) means it is unlikely they will be completely drowned.

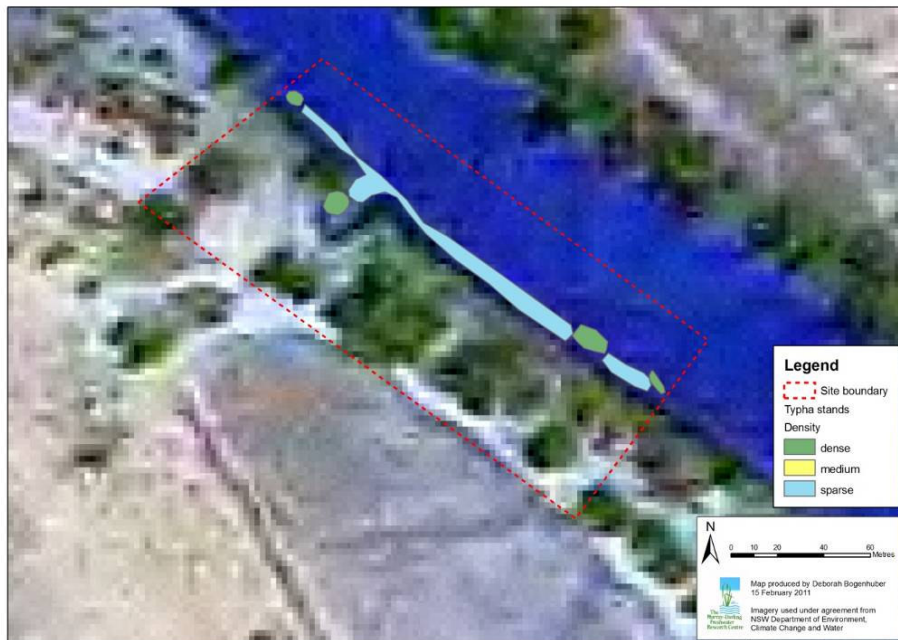
Figure 4.17. Distribution of *Typha* at site 16, Darling Anabranh.

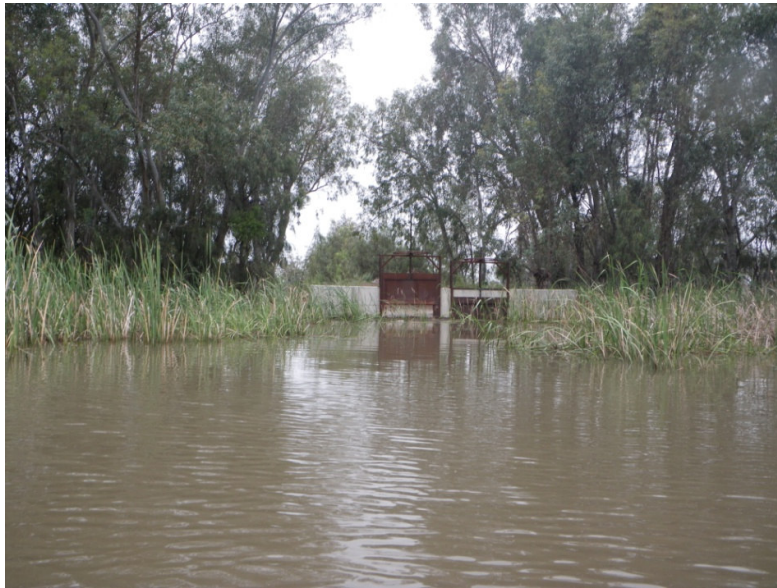
Figure 4.18. *Typha* stands at Oakbank Dam, near sites 15 and 16 (D. Linklater, MDFRC, 17/11/2010).
